# Property external renovation Case Study

**Client –**  
Hoburne Development Company Limited

**Contractor –**  
Homeshield Coating Limited

**Site Location –**  
New Milton, Dorset. BH25 7QT

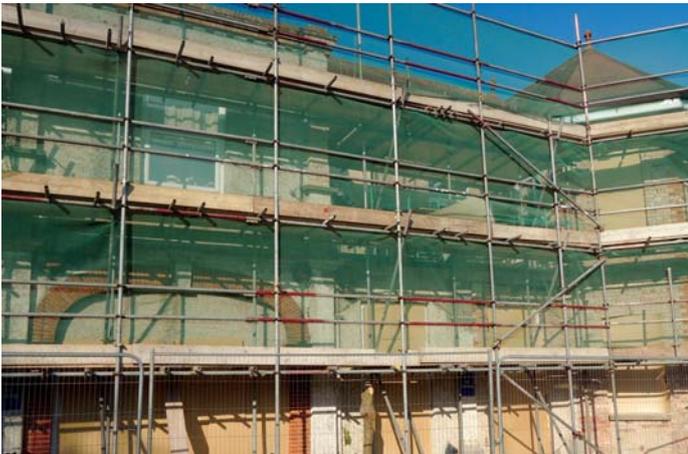
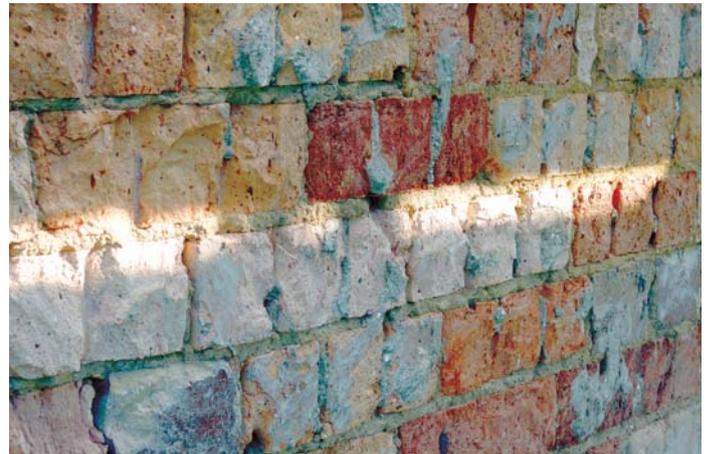
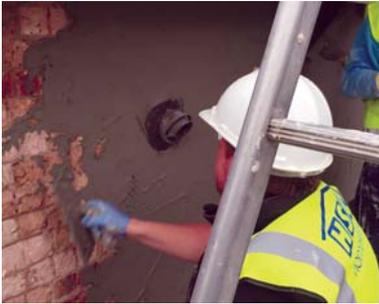
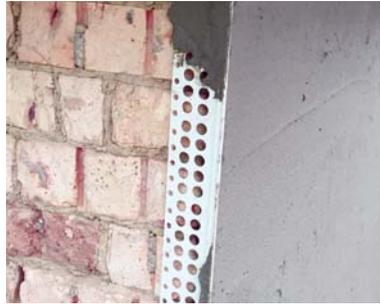
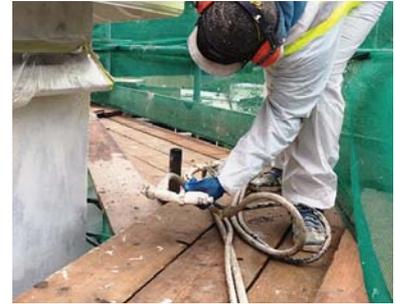
The external render on the property was a miss-match of varying cements and aggregate sizes. Having removed all the old render and with the underlying brick substrate found to be in varying condition, a render solution which delivered both long-term protection and would adhere well to the old, non-uniformed brickwork was sought.

Homeshield in consultation with Wetherby Stone Products specified **Wethertex GRC backing coat render, a fibre re-enforced, high-polymer trowel applied render** which is designed to adhere well to difficult substrates and act as a water-proofing backing coat for subsequently applied decorative finishes. **Upvc angle corner/angle beads** were used to prevent the likelihood of any future corrosion.

Following the application of backing and subsequent render coats and allowing the manufacturer's recommended drying times, a decision was made by the client to choose **Wethertex MP44 Pliolite acrylic resin based texture coating** as the final decorative & protective finish.
