Property external renovation Case Study

Hoburne Development Company Limited

New Milton, Dorset. BH25 7QT

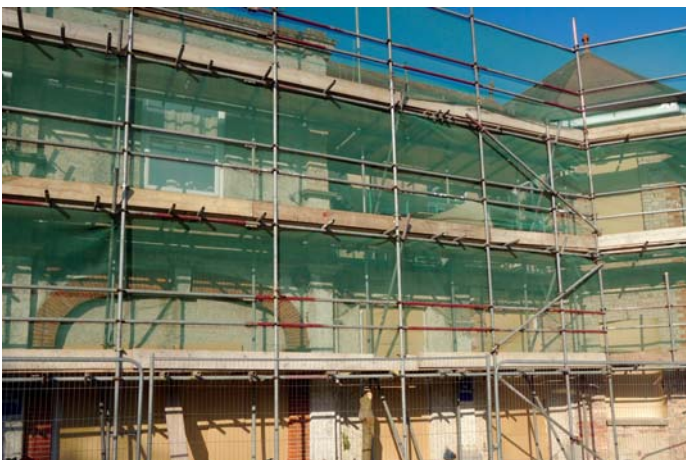
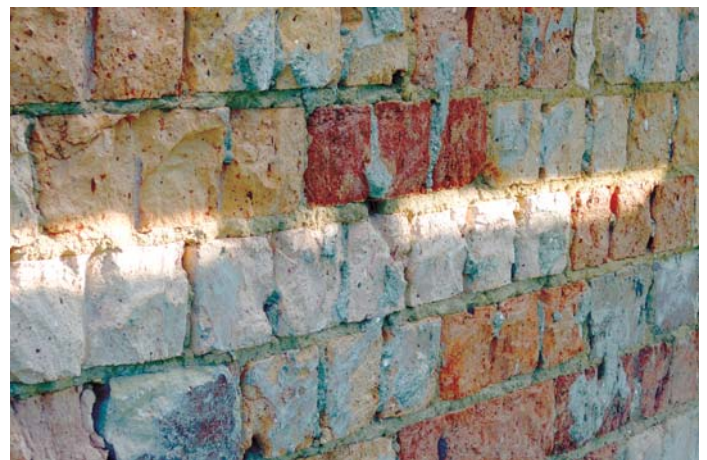
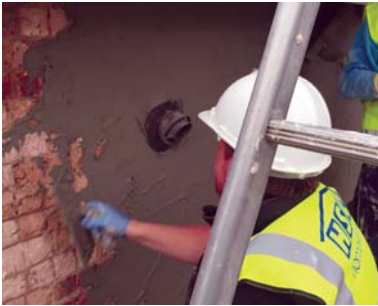
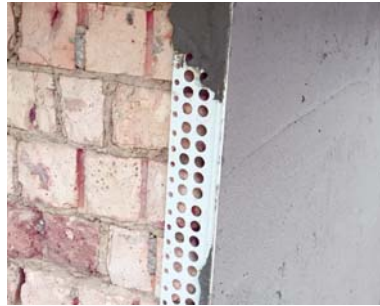
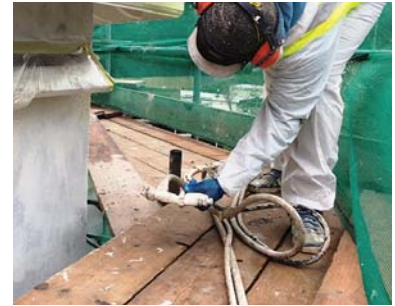
The external render on the property was a miss-match of varying cements and aggregate sizes. Having removed all the old render and with the underlying brick substrate found to be in varying condition, a render solution which delivered both long-term protection and would adhere well to the old, non-uniformed brickwork was sought.

Homeshield in consultation with Wetherby Stone Products specified **Wethertex GRC backing coat render, a fibre re-enforced, high-polymer trowel applied render** which is designed to adhere well to difficult substrates and act as a water-proofing backing coat for subsequently applied decorative finishes. **Upvc angle corner/angle beads** were used to prevent the likelihood of any future corrosion.

Following the application of backing and subsequent render coats and allowing the manufacturer's recommended drying times, a decision was made by the client to choose **Wethertex MP44 Pliolite acrylic resin based texture coating** as the final decorative & protective finish.
